Performance of exterior facade on reinforced concrete frame under cyclic loading

Prathamesh Kulkarni¹, Devyani Tewatia²[0000-0002-8504-3442], P. C. Ashwin Kumar²[0000-0002-0681-377X], Shounak Mitra³, Manish Shrikhande² and Pankaj Agarwal²

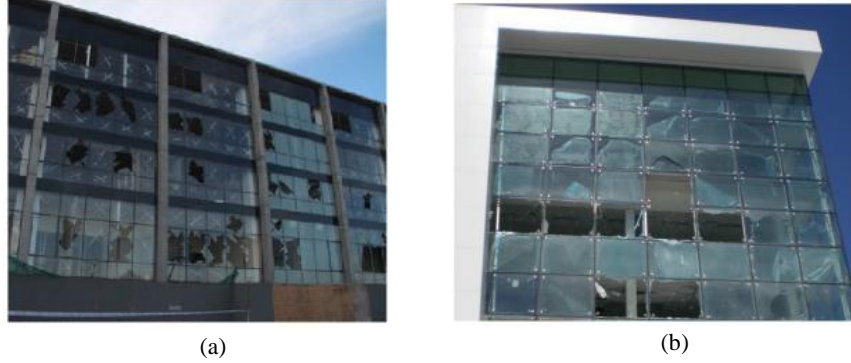
Figure 1. Glazing damage observed in past earthquakes (a) 2010 Chile earthquake (b) 2011 Christchurch earthquake.

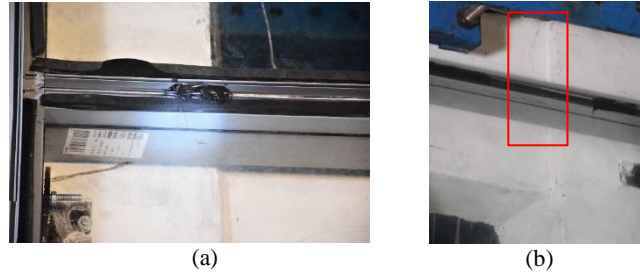
Till 0.5% drift, no cracking in any part of the test specimen, including the RC frame and GCW, is observed. At 1% drift, the structural sealant used to join the glass with the aluminum frame started coming out of the double-sided sealant stip. This observation indicates the interaction of the glass panel and aluminum frame. A vertical crack in the beam near the beam-column joint at the 2nd floor beam is also observed (Figure 6(b)). At 1.4% lateral drift, spalling of concrete is observed (Figure 7(a)) at the top left corner of the RC frame. This may be attributed to the interaction between the loading beam and the second-floor beam. The glass panel failure is observed at 3.5% drift.

Figure 6. (a) Squeezed silicon fluid, (b) Cracks near the beam-column joint.

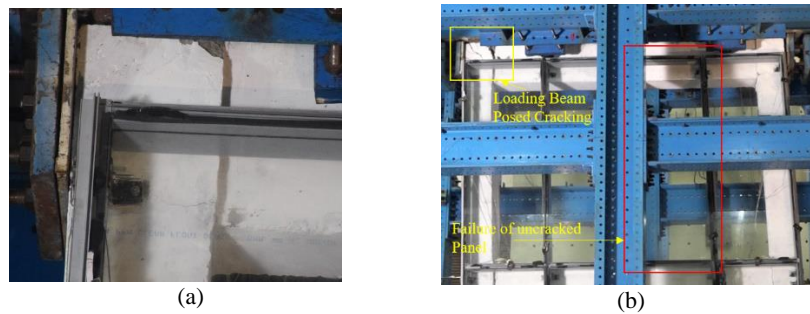
Figure 7. (a) loading beam-RC frame interaction (b) falling-out failure of the glass panel

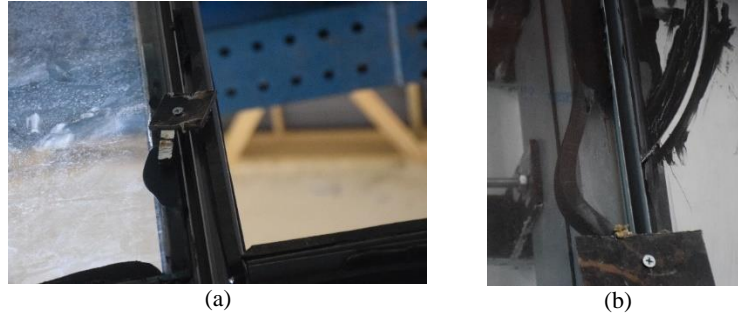
Finally, at 5% drift, fallout-type failure of other glass panel occurred. During the inspection carried out post-completion of all loading steps, it is observed that clips installed to fix the glass panels temporarily had dislocated. The structural sealant double-sided tape used to paste glass panels is observed to be dislodged, as shown in Figure 8. A random clearance has been provided between the face of the aluminum section, and the edges of the glass have varied, and the functionality of GCW has been lost.

Figure 8. (a)Tilted clip placed on intermediate mullion (b) Squeezed silicon and damaged silicon tape of the concrete frame

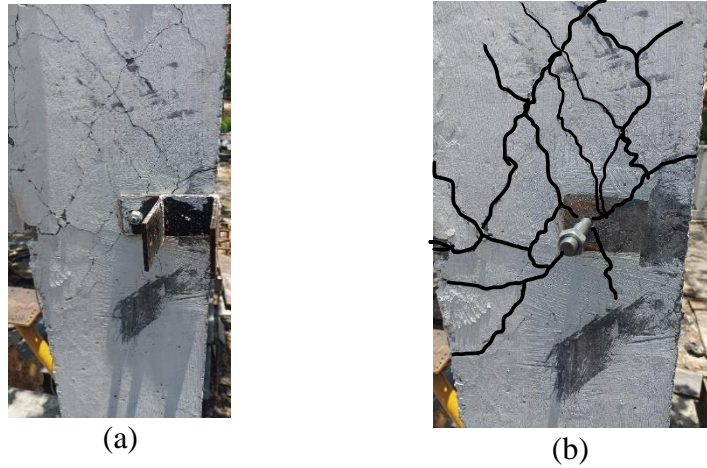
Post completion of the test, major cracks are found to be concentrated near the joint. In Figure 9, the top right corner has been shown with and without bracket. Crack measured over all joints varied in size. Most of the anchors in the cracked concrete filed by slipping from the cracks in the pull-out strength with reduced capacity.

Figure 9. (a) Image of cracked joint with bracket (b) Mapped cracking and cracks passing through anchors

From visual inspection after testing, it is found that the four-way joint and connection of the GCW frame to the RC frame remained undamaged. No damage is observed in the mild steel bracket and Hilti M10 post-installed anchors connections. Minor cracks have been observed in the RCC frame passing through the anchor location at the connection in the left column adjacent to the bottom beam-column joint. LVDTs that are placed in the out-of-plane direction of the middle point of the mullions recorded an insignificant amount of displacement value. Also, no out-of-plane buckling of aluminum sections is observed.

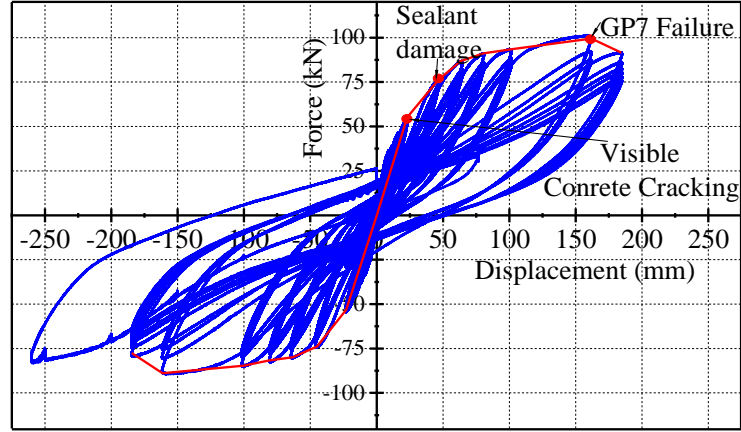
The hysteresis curve is plotted for RCC frame, as shown in Figure 10. The RCC frame has a maximum capacity of 101 kN at 122.6 mm displacement. The sealant damage is

seen at 50 mm displacement. The first glass panel failure is also observed at peak load of the frame.

Figure 10. Hysteresis curve of the RCC specimen

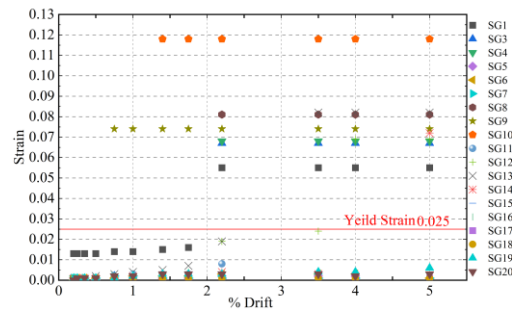
The state of strain level at the point located in the abovementioned figure has been determined in all subsequent steps for associated drift from most of the working strain gauges placed on rebars and plotted in Figure 11. The top bars of the upper beam yielded at 0.75% drift followed by left column bars near the top corner at 1.75% drift. The strain data for aluminum sections indicated strain less than yield strain, except SG 25, thus indicating aluminum sections have not been yielded and remained elastic throughout the test. Due to local deformations, an aluminum section at a point located near SG25 has yielded, as shown in Figure 12. Figure 12 (a) is a plot of strain data from all working SG, and Figure 12 (b) is a plot of strain data from the same SGs except SG25. It is an industrial practice to consider the end condition of the mullion/transom as a pin connected, evidenced by feeble elastic strain recorded near the mullion-transom joint.

Figure 11. Strain status at various strain gauge locations placed on the rebars.

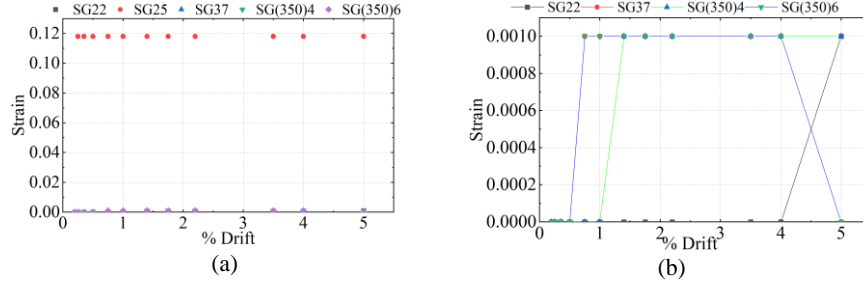
Figure 12. (a) Strain status with the advancement of loading in all working SG's (b) Feeble strain recorded by SG's placed on aluminum sections except SG25
